1. AGENCY USE ONLY (Leave blank)		2. REPORT DATE 2/8/95	3. REPORT TYPE AND DATES COVERED Final Report 6/15/94 - 12/15/94
4. TITLE AND SUBTITLE Electrochemical Impedance Pattern Recognition for Detection of Hidden Chemical Corrosion on Aircraft Components			5. FUNDING NUMBERS Air Force SBIR Phase I F49620-94-C-0043

6. AUTHOR(S) A.F. Sammells and J.S. Bowers			3005/SS 65502F
7. PERFORMING ORGANIZATION NAME(S) AND ADDRESS(ES) Eltron Research, Inc. 2830 Wilderness Place Boulder, CO 80301			8. PERFORMING ORGANIZATION REPORT NUMBER Final Report Project 067 AFOSR-TR-95-0106

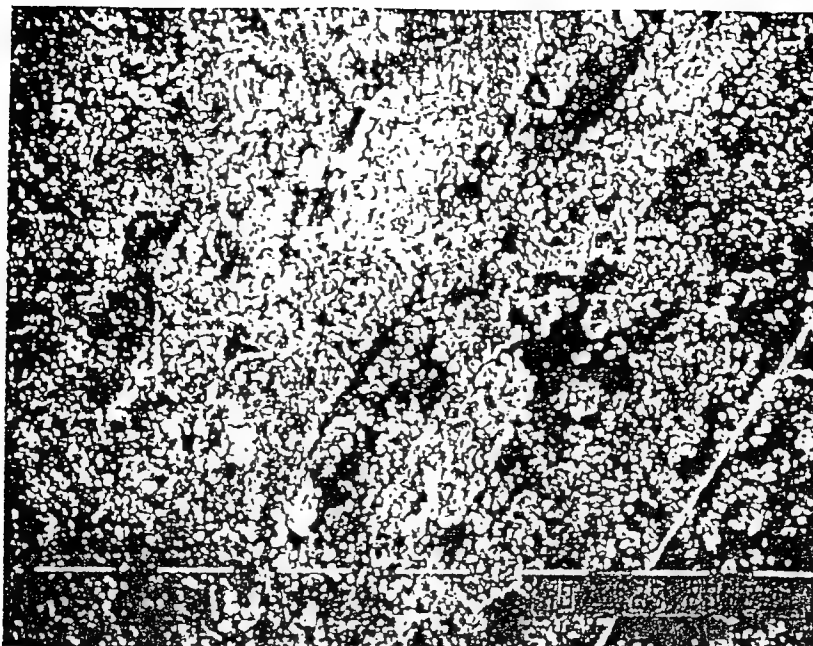
Figure 53. Scanning electron micrograph of Ti 15-3 coupon after 1412 hours exposure to 0.1M HNO₃ at Ti 15-3/Al 7075 interface. Bright material is corrosion product which visually appears copper colored. Dimension shown = 10 microns.
